Sixth Annual Monitoring Report

Oak Woodland Habitat Revegetation/Mitigation Program for the Santa Anita Dam Riser Modification and Reservoir Sediment Removal Project

September 2022

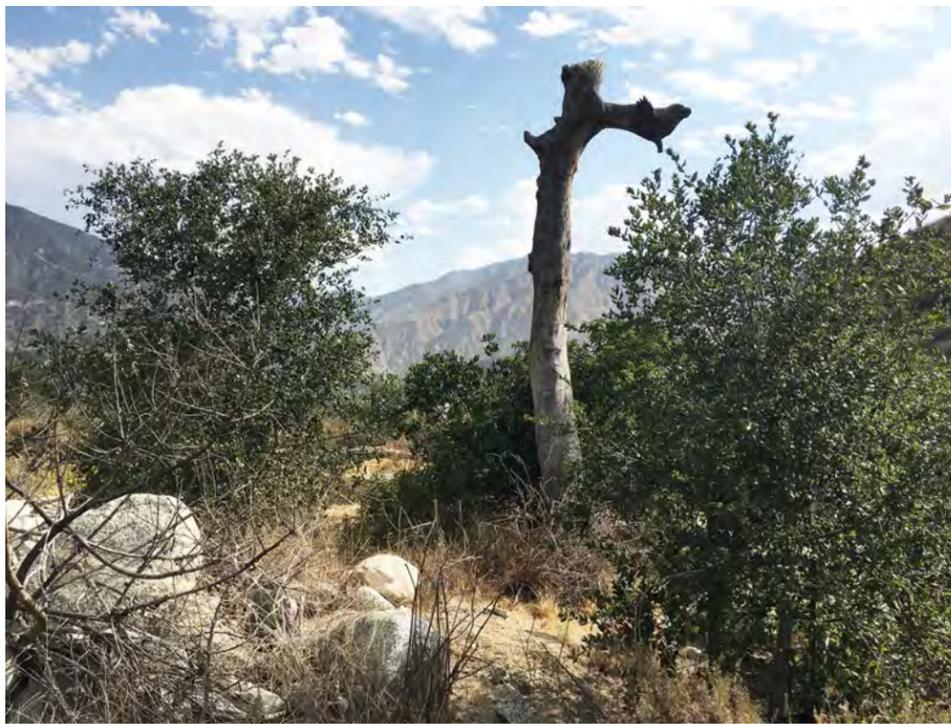
June 2021. A placed natural snag stands between two planted oaks. Approximately 44 percent of the oak saplings exceeded 10 feet in height, and approximately 21 percent of the oaks exceeded 12 feet in height, in spring 2021.

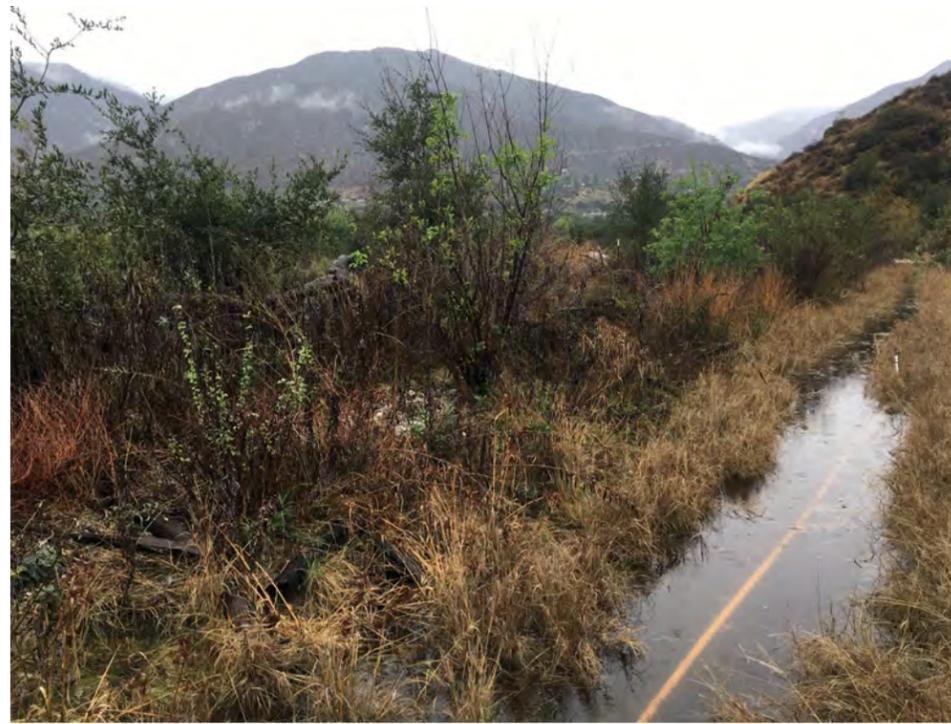
January 2021. The planted oaks benefit from the spiraling drainages that were designed by Los Angeles County Public Works (LACPW) to broadly distribute storm flows across the deck of the Lower Sediment Placement Site (SPS).

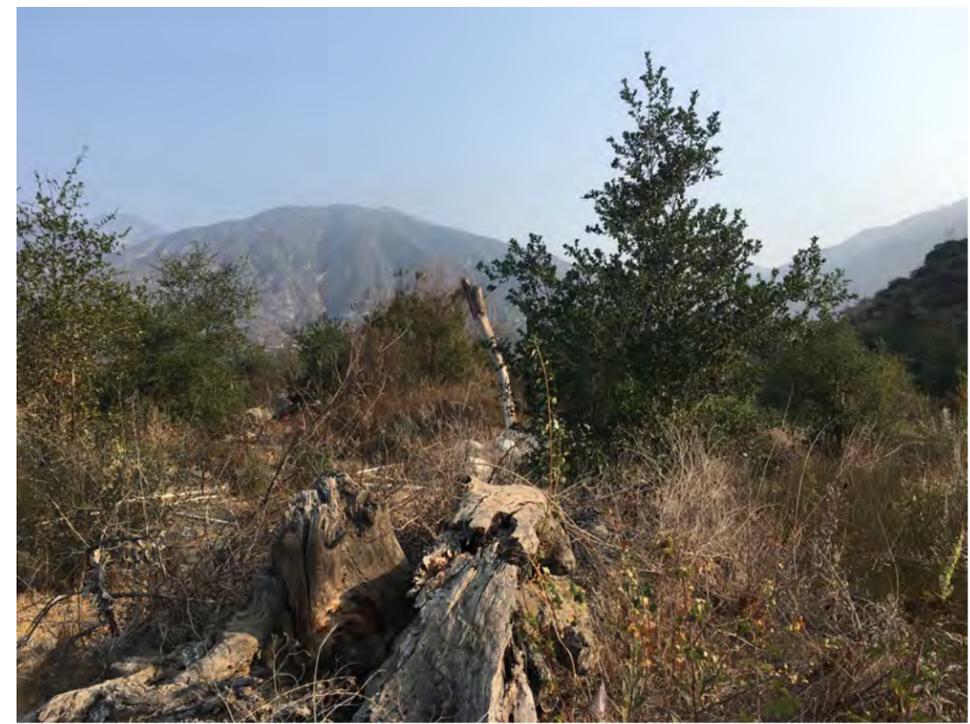
August 2021. Drought-resilient planted oaks occur amid native understory vegetation that exhibits seasonal desiccation and effects of ongoing drought. Placed natural coarse woody debris is shown in the foreground.

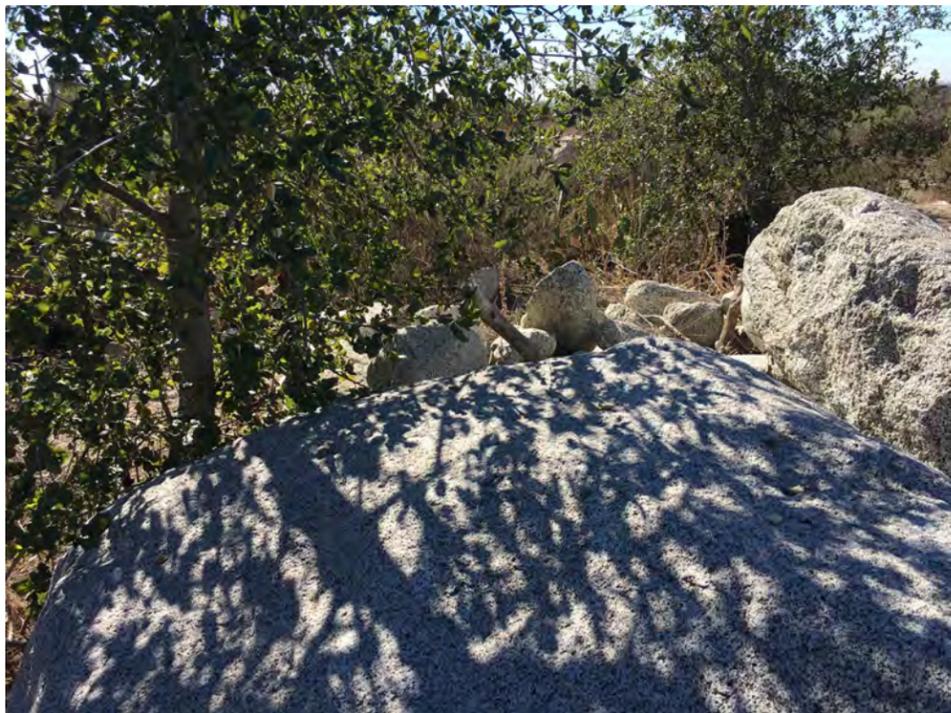
November 2021. The planted oaks are beginning to provide shade beneath their expanding canopies. The shading has benefits for wildlife and provides niches for some native plant species that are intolerant of full sunlight.

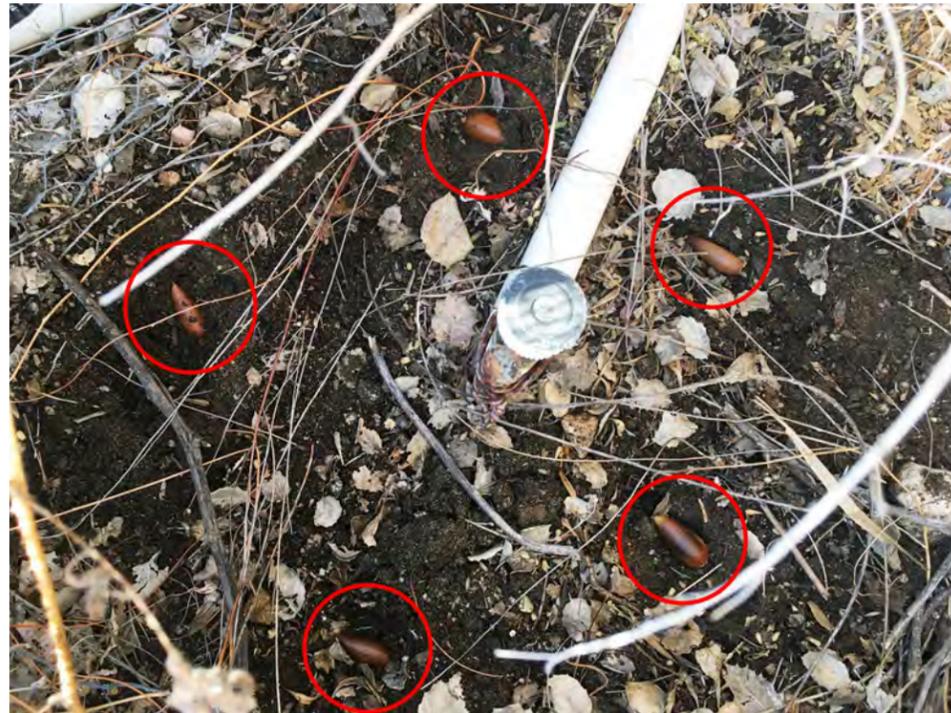
December 2020. Under the terms of the habitat mitigation plan, acorns were to be planted every fall for the first five years of the maintenance period. However, LACPW continued to install acorns annually through year six on a voluntary basis.

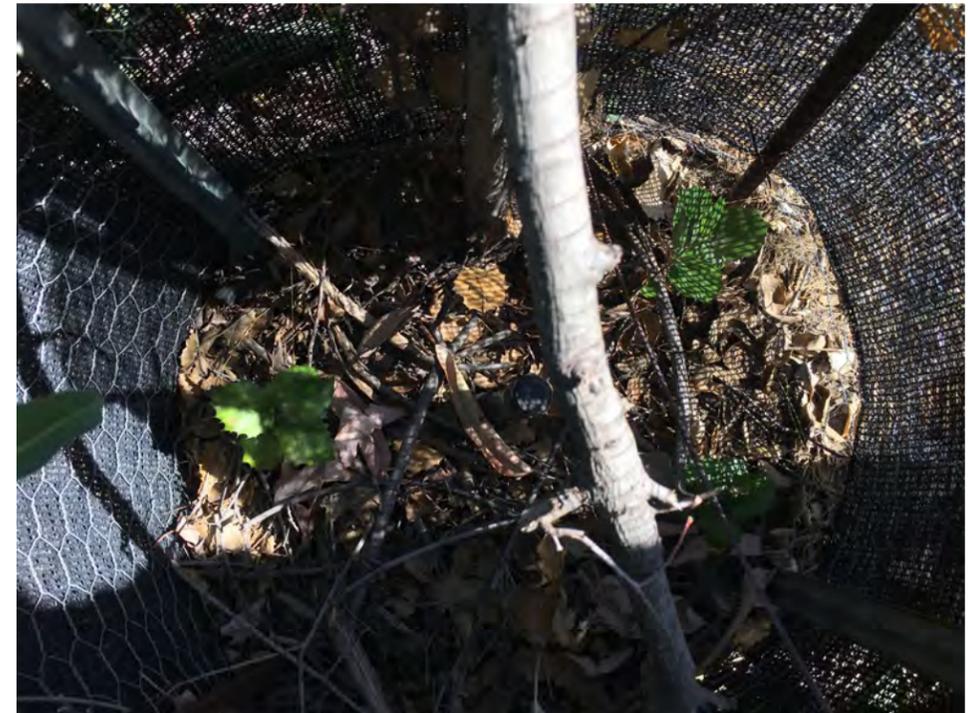
May 2021. New coast live oak seedlings are shown within a planting cage. These seedlings resulted from the planting of locally-harvested acorns that were installed on the mitigation site in fall 2020.

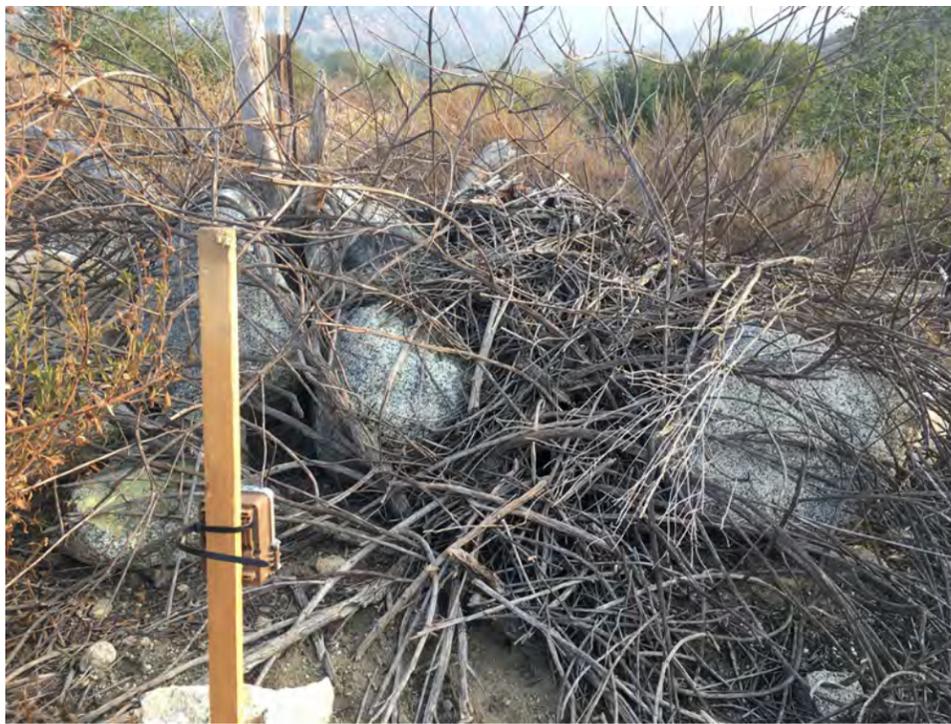
August 2021. A motion-activated wildlife camera was positioned next to a suspected wood rat nest that was constructed in a placed assemblage of boulders and fine woody debris. The results are shown in the photograph below.

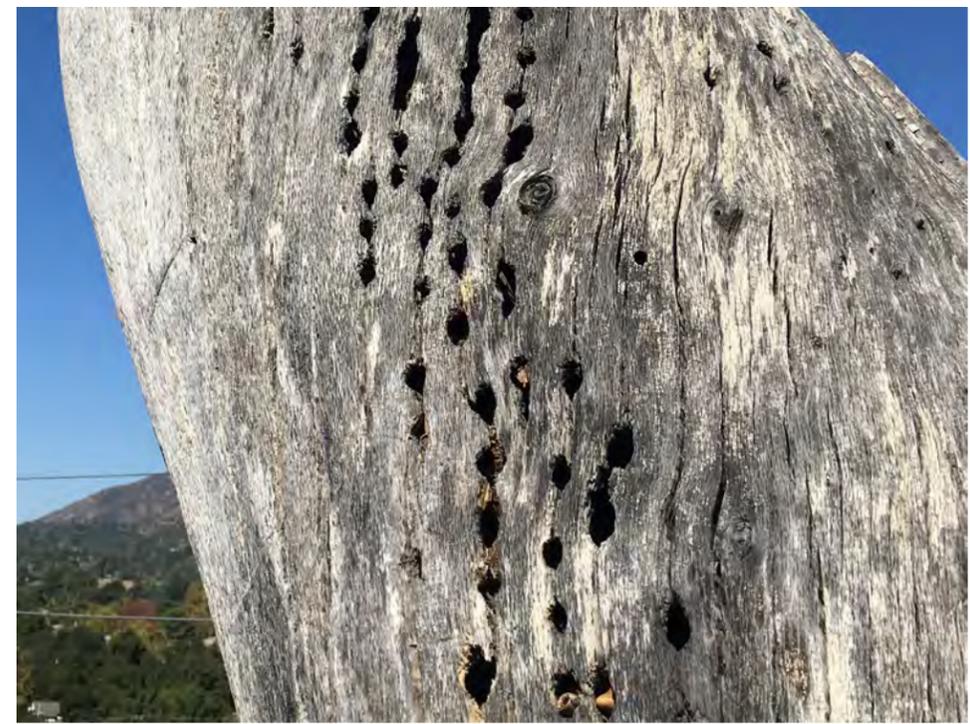
October 2021. Acorn woodpeckers have excavated holes in this placed natural snag which they are using as a valuable acorn 'granary'.

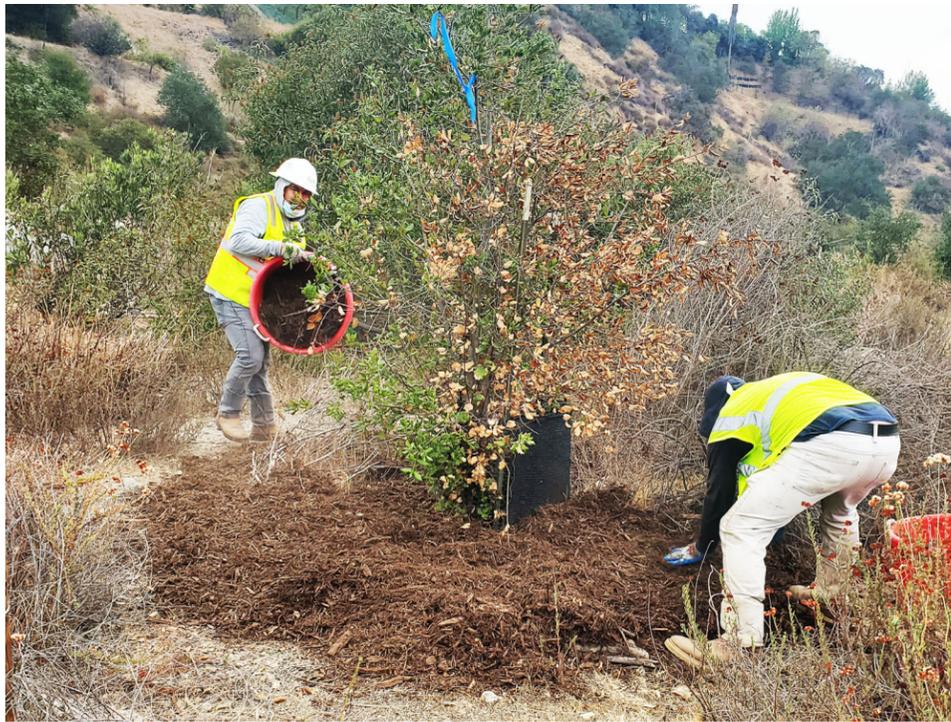
August 2021. The Restoration Contractor (Nakae and Associates, Inc., Psomas' subcontractor) is placing fully composted, natural mulch around a drought-stressed oak at the direction of Psomas Certified Arborist.

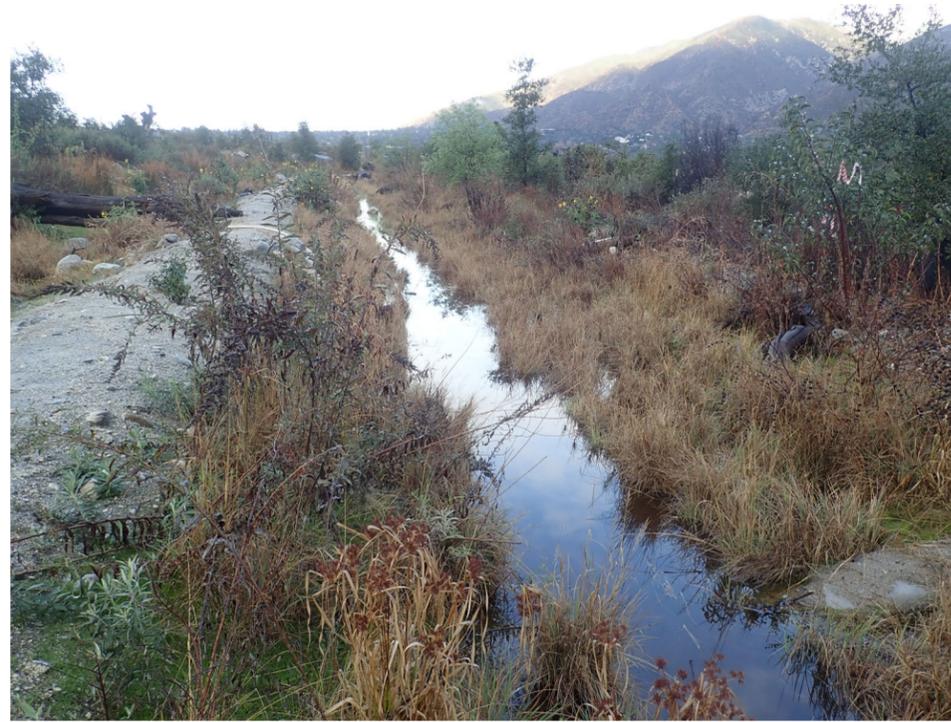
January 2021. The Restoration Contractor periodically removes vegetation from the central two-foot-width within each drainage to facilitate inspection.

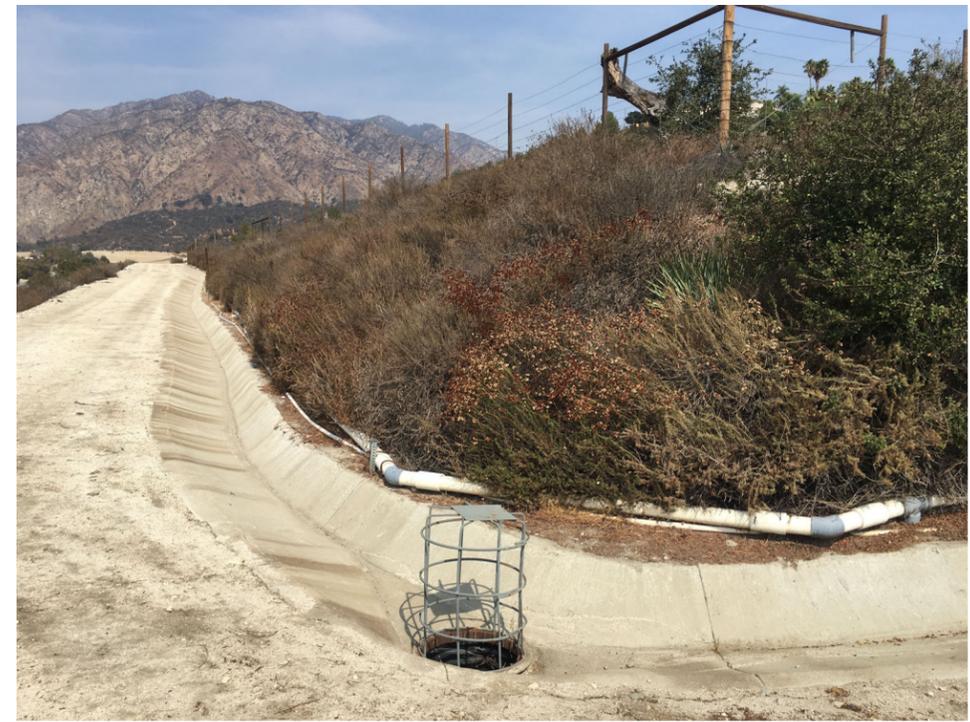
September 2021. The Restoration Contractor regularly removes sediment and plant debris from the downdrains, v-ditches, and inlets to maintain proper drainage on the Lower Sediment Placement Site (SPS).

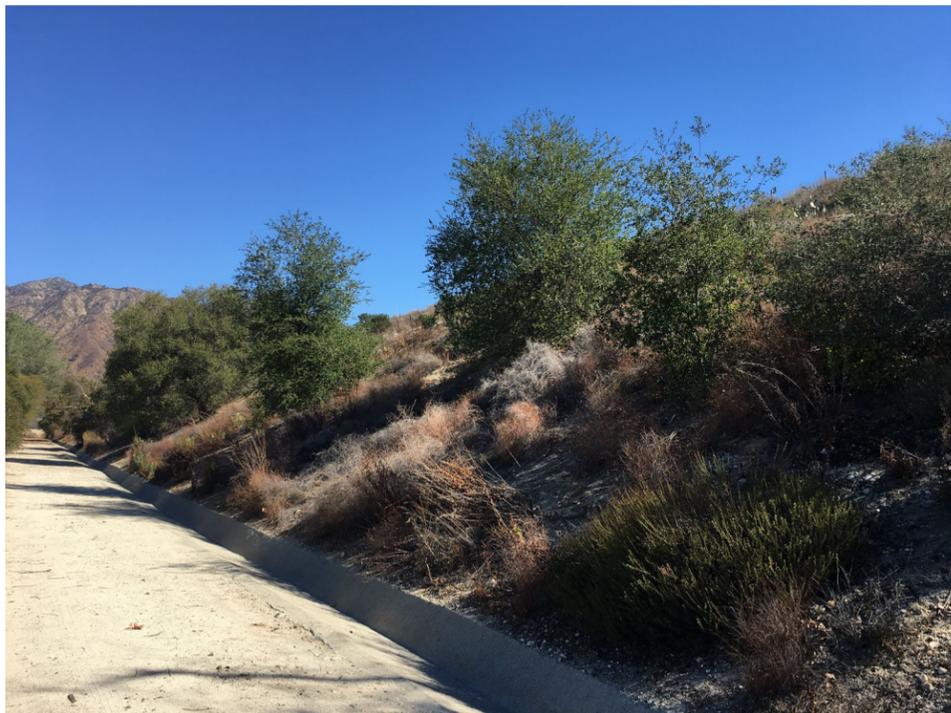
October 2021. Los Angeles County Public Works has performed voluntary maintenance on a total of 7.38 acres of Weed Abatement Buffer Areas (Buffer Areas) to reduce weed seeds, reduce fire hazards, and promote native plant recruitment.

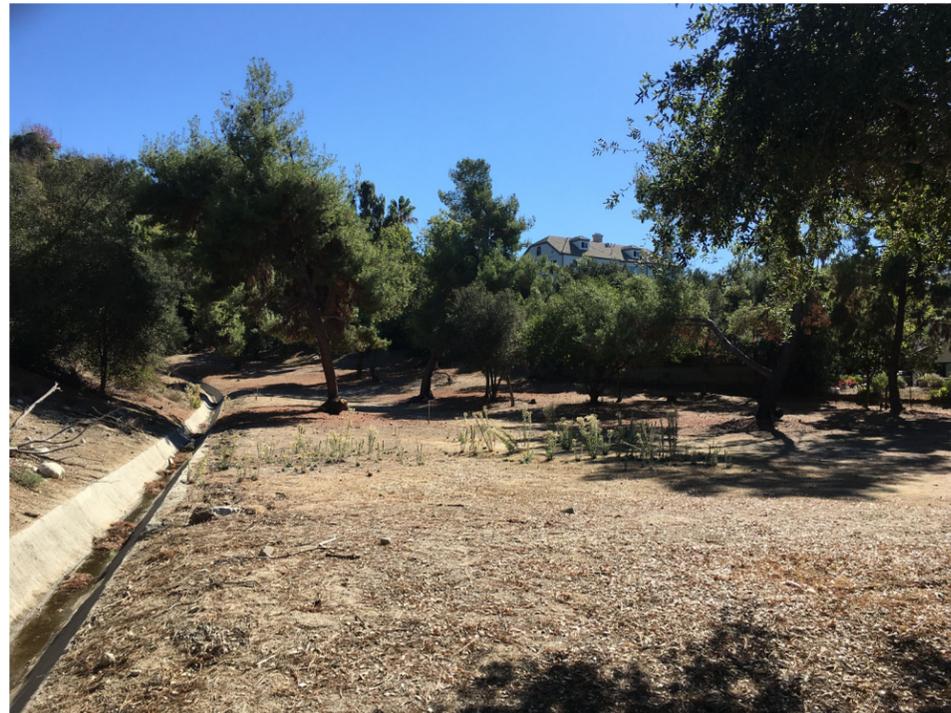
October 2021. Buffer Area 4 is periodically weeded to reduce fire fuel hazards.

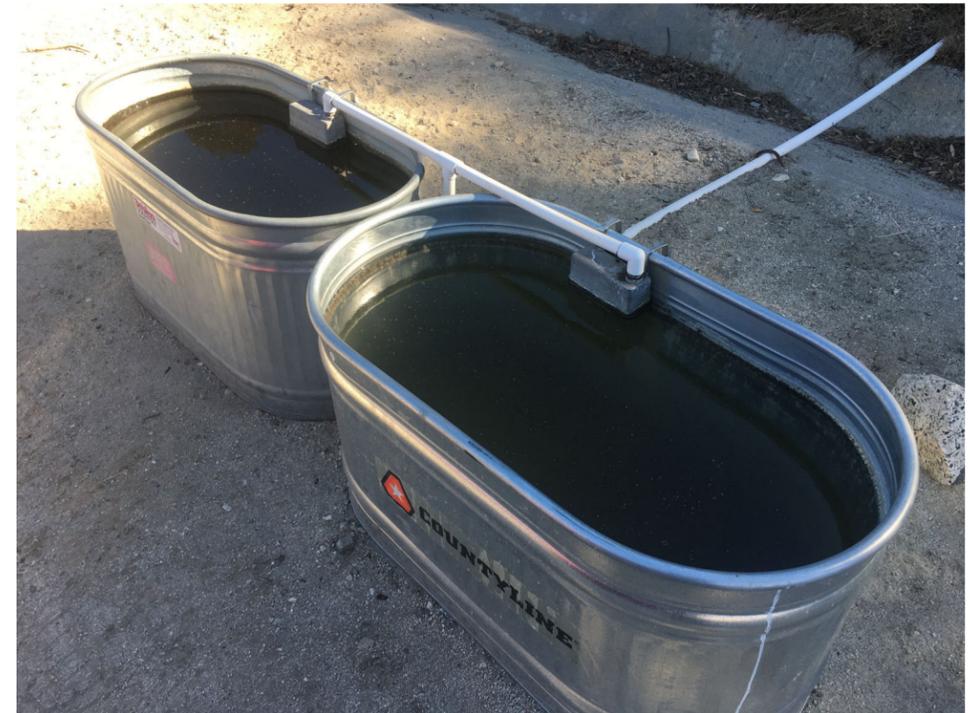
December 2020. 'Drinker' tanks were installed in 2013 to provide a temporary water source for wildlife while a portion of the oak woodland mitigation site is excluded to protect developing oaks from excessive herbivory.

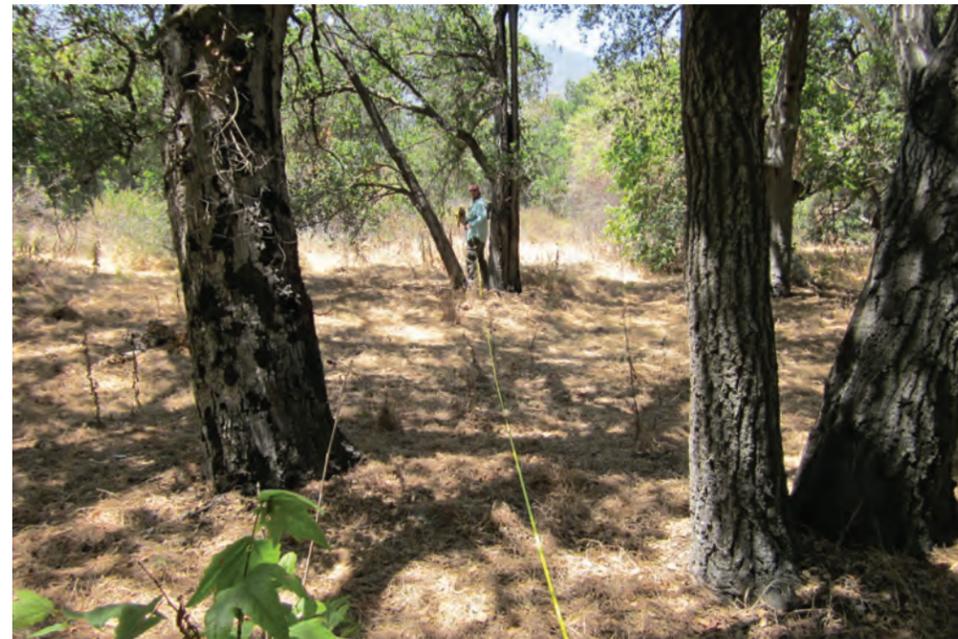
July 2013. The oak woodland reference site (Middle Sediment Placement Site [SPS]). Although the reference site contains numerous mature coast live oak and western sycamore trees, the understory vegetation is predominantly weedy (e.g., ripgut brome [grass]).

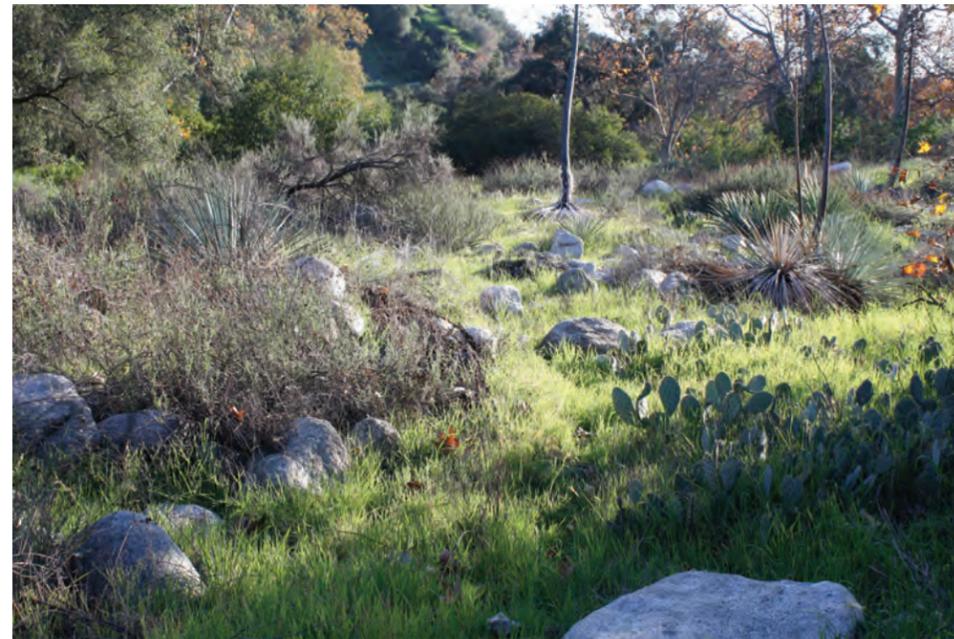
January 2011. The coastal sage scrub reference site (Middle SPS) exhibits patches of native scrub and a dense understory of weedy grasses and herbs.

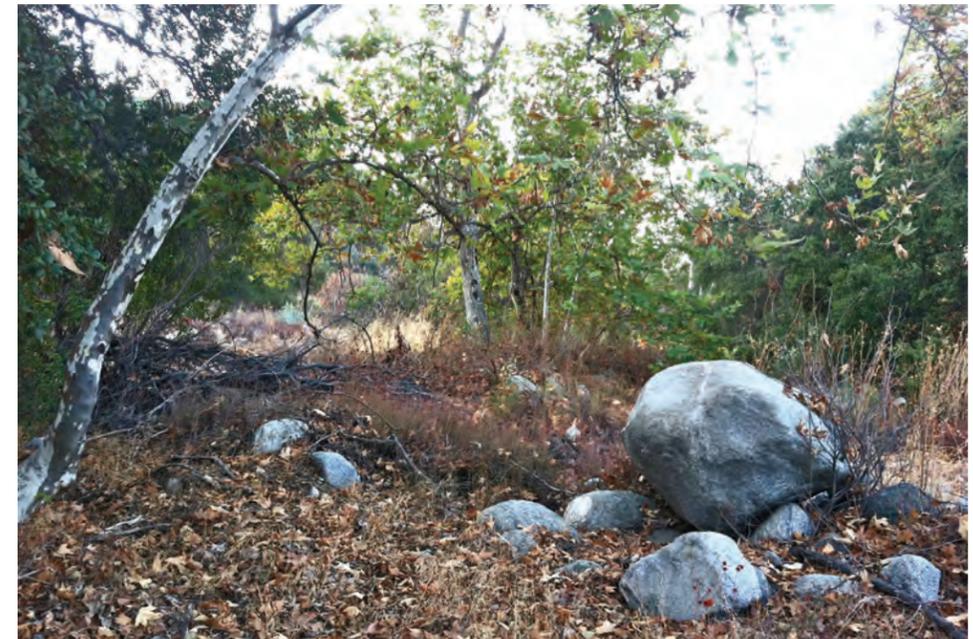
October 2012. The Middle SPS reference site contains some natural boulders and coarse woody debris, which are beneficial habitat features that are being recreated on the Lower SPS mitigation site.
